WEATHERING RISK

DRAWING TITLE: Flat Roof Abutment

DRAWING No: EP-057

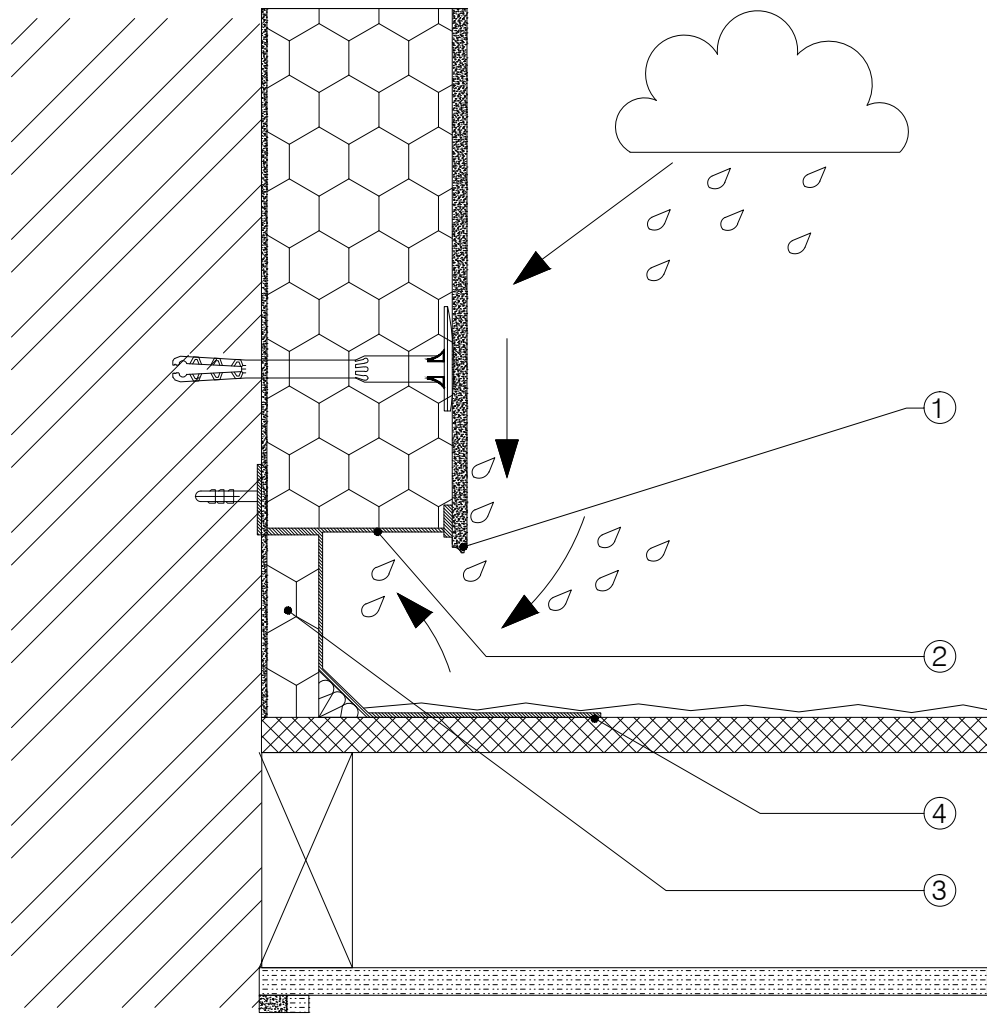
- INADEQUATE FREE DRAINAGE OF WATER FROM THE BOTTOM OF THE RENDER PREVENTS RENDER SURFACE FROM DRYING.

- MAINTAIN A CLEAR GAP BETWEEN THE BOTTOM EDGE OF THE RENDER AND THE SURFACE BELOW. BOTTOM OF THE SYSTEM PROTECTED BY A PLASTIC (LOW THERMAL CONDUCTIVITY) OR METAL STARTER TRACK/BASE TRACK.

1. Maintain clearance below render to allow free drainage of water from the base of the system.
2. Bottom of insulation protected by plastic or metal closure (with drainage holes if required).
3. Insulation to provide not less than 75% of the thickness or thermal resistance of the main wall insulation Either: High density insulation with bashing band over lapped onto roof, or proprietary insulated flashing (thermaflash or similar approved).
4. Flashing.
